Manhole Inspection Summary

Manhole # S25CC_010MH

Location Address: **1130 SMITHSON ST**

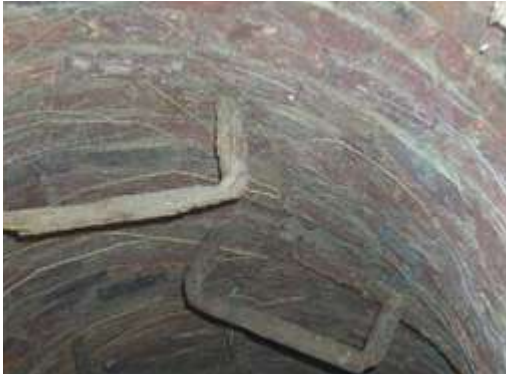
Defect 4

Condition: ☐ Sound ☐ Cracked ☒ **Root Intrusion** ☐ Loose Brick ☒ **Deteriorated**

Condition: ☐ Sound ☐ Cracked ☒ **Root Intrusion** ☐ Loose Brick ☐ Deteriorated

ROOT INTRUSION ON CORBEL AND BARREL

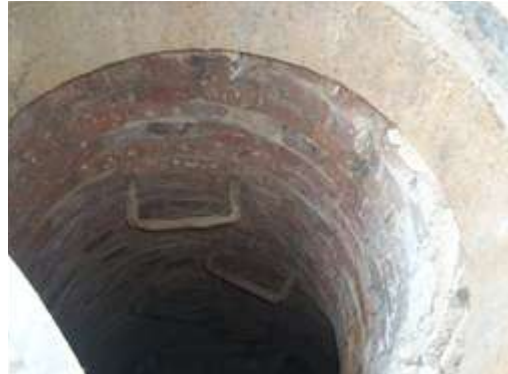
Defect 3

Count: **5** Missing: **1** ☒ **Corroded**

CORRODED AND MISSING STEPS

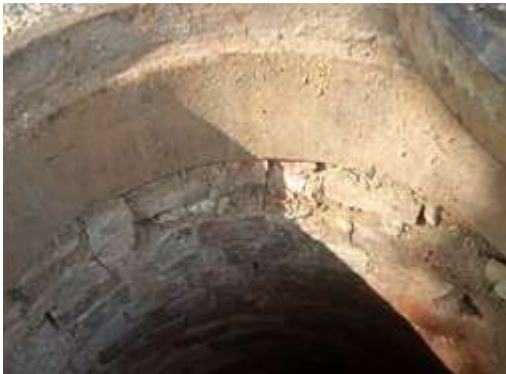
Defect 2

DETERIORATED CORBEL

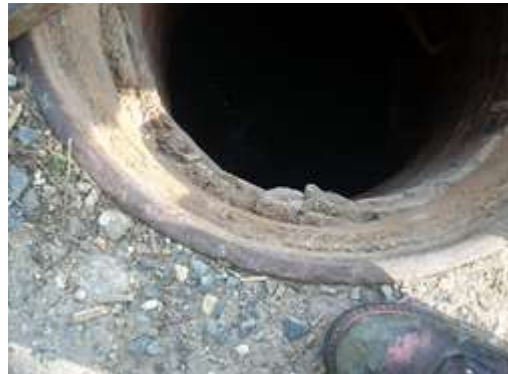
Defect 1

Offset: **2** (in.)

FRAME OFFSET

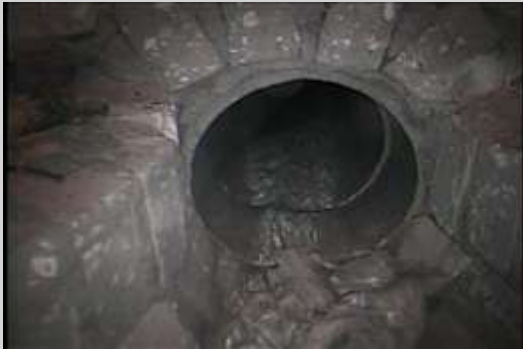
12 O'Clock Outflow

Pipe Height: **7.2** (in.) Rod and Bar (Angled)
Pipe Material: **Clay** ☐ Pipe Lined
Invert Depth: **8.81** (ft.) Flow Characteristics: **Slow**
Deposits: ☐ None ☐ Mud ☐ Sludge ☒ **Debris** ☐ Grease
Silt Depth: **1** (in.) Deposits Extent: **Light**
Infiltration: **None** Pipe Seal Cond: **Sound**

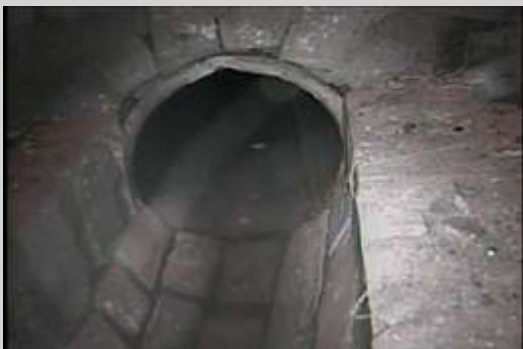
3 O'Clock Inflow

Pipe Height: **7.2** (in.) Rod and Bar (Angled)
Pipe Material: **Clay** ☐ Pipe Lined
Invert Depth: **8.19** (ft.) Flow Characteristics: **Slow**
Deposits: ☒ **None** ☐ Mud ☐ Sludge ☐ Debris ☐ Grease
Silt Depth: (in.) Deposits Extent:
Infiltration: **None** Pipe Seal Cond: **Broken**

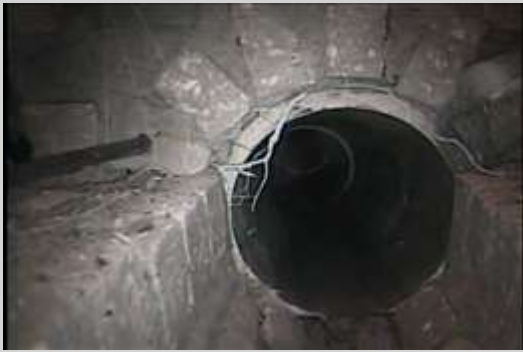
6 O'Clock Inflow

ROOT INTRUSTION
